ADVANCED COMPOSITE ELEVATOR FOR BOEING 727 AIRCRAFT VOLUME 2—FINAL REPORT

Boeing Commercial Airplane Company
P.O. Box 3707, Seattle, WA 98124

CONTRACT NAS1-14952
NOVEMBER 1980

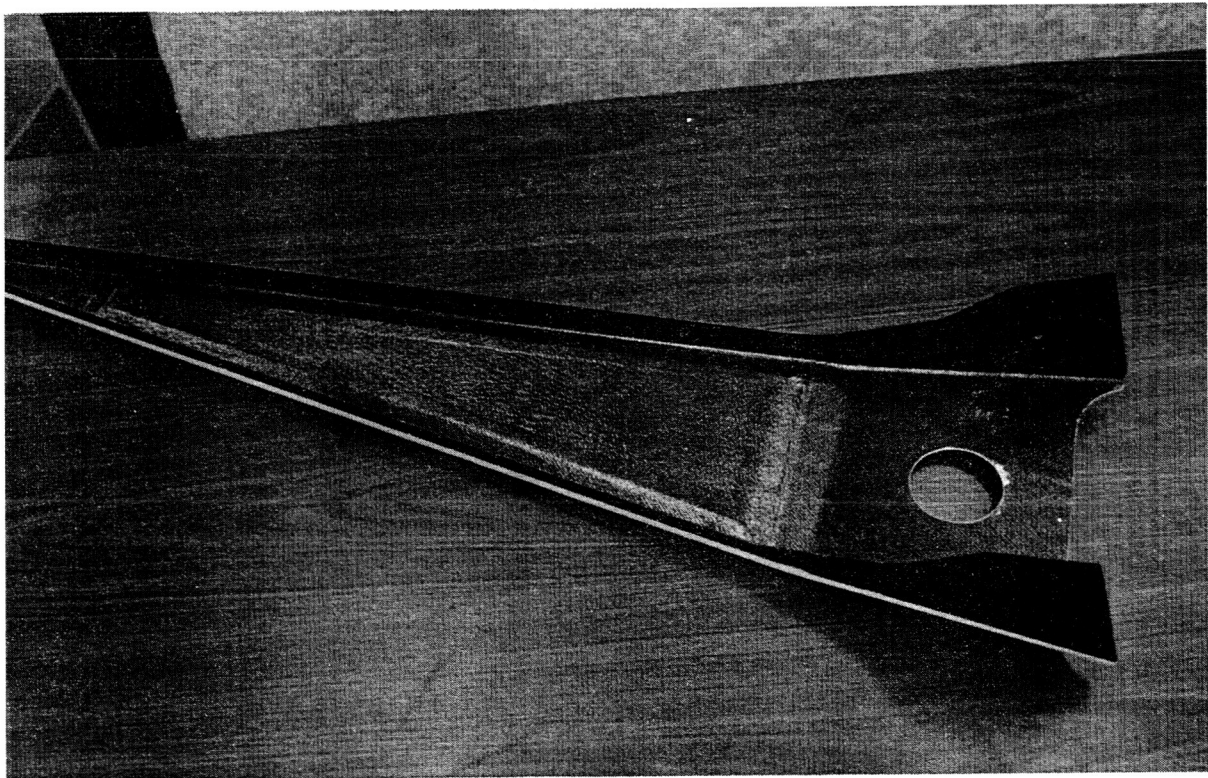
Figure 255. Inboard Closure Rib

Female layup mandrels presented problems with bridging of materials in the outside radius of flanges, which created resin ridges and voids. Typical of parts exhibiting this condition were the inboard closure rib (fig. 255), the station 117.37 rib spar attach flange (fig. 256), the joggled area along the skin panel leading edge, and radius areas on the actuator fairing. Changes to radius size, where allowable, and staged compaction corrected some of the problem, but not completely. Because analysis of representative areas indicated that structural properties of the parts were not affected, sanding of ridges and filling of voids with adhesive were authorized and applied to finish the parts.

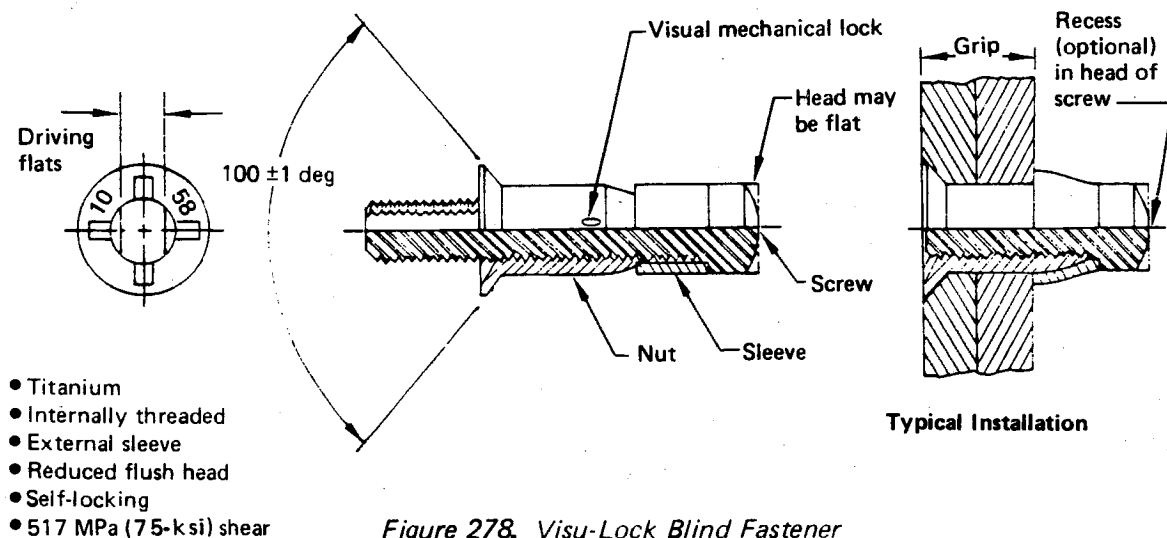
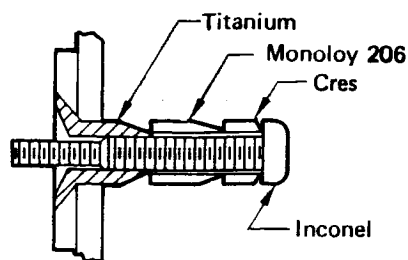
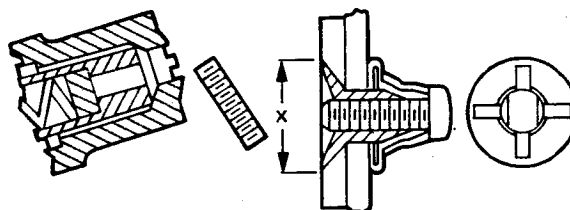
Figure 279. Installation Procedure of Monogram/Aerospace "Bigfoot" Fastening System

Bigfoot fastener is inserted in hole drilled through members to be joined.

Power is applied and screw is wrenched while nut is held. The bearing sleeve, compressed between the nut and the column sleeve, expands and is drawn over the tapered shank of the nut. The column sleeve is drawn over the bearing sleeve, forming a large head that grips the mating surfaces of the material being joined.

Positive sheet clamp-up is simultaneously effected. Slabbed portion of screw shank is snapped off as soon as Bigfoot is fully driven.

- Diameters = 4.76 mm (3/16 in) to 7.94 mm (5/16 in) plus 0.79 mm (1/32 in) oversize
- Grip lengths = increments of 1.27 mm (0.050 in)
- Flush/protruding head

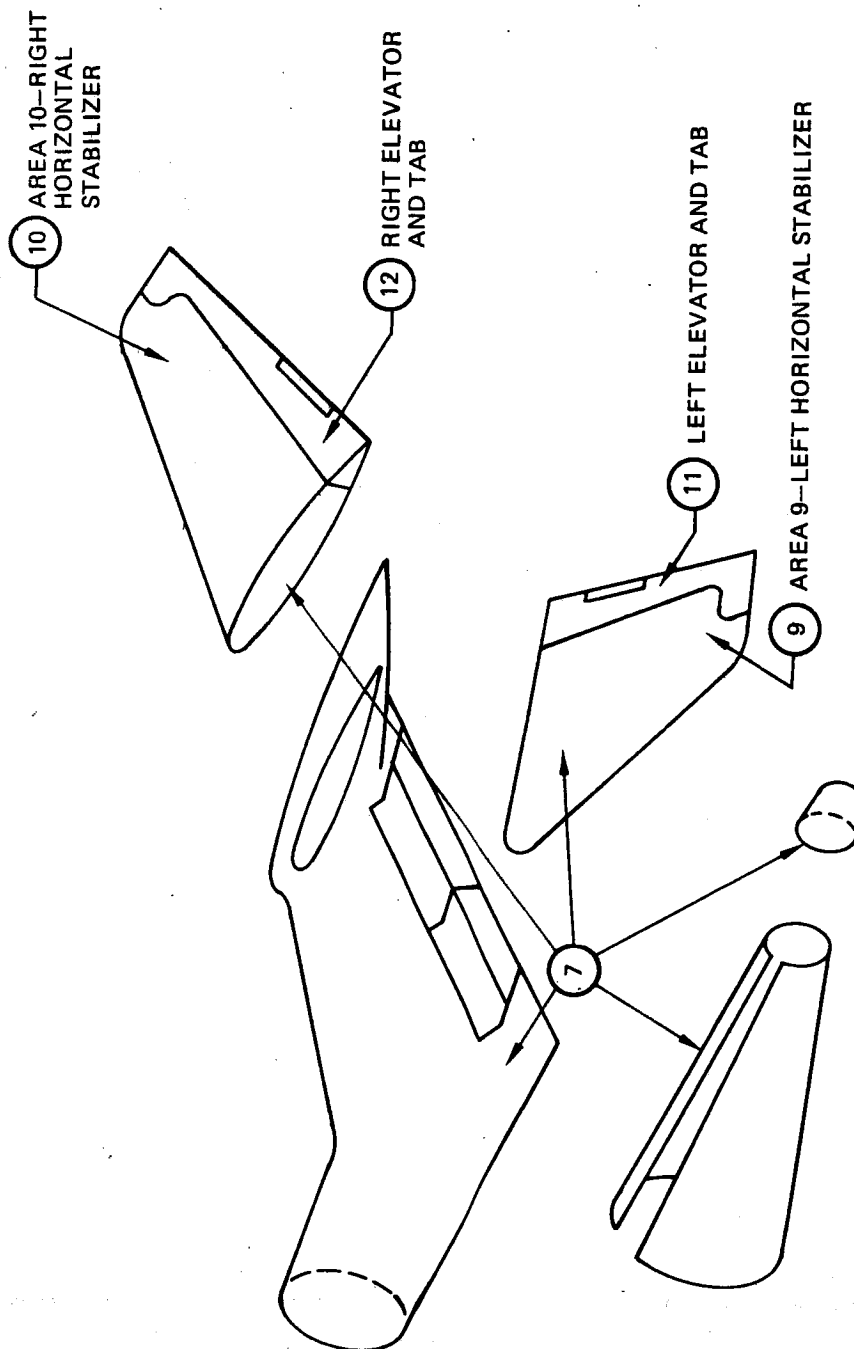
Zone 7--Empennage

- Zone 1 --upper half of fuselage (reference)
- Zone 2--lower half of fuselage (reference)
- Zone 3--left wing (reference)
- Zone 4--right wing (reference)
- Zone 5--left nacelle (reference)
- Zone 6--right nacelle (reference)
- Zone 7--empennage

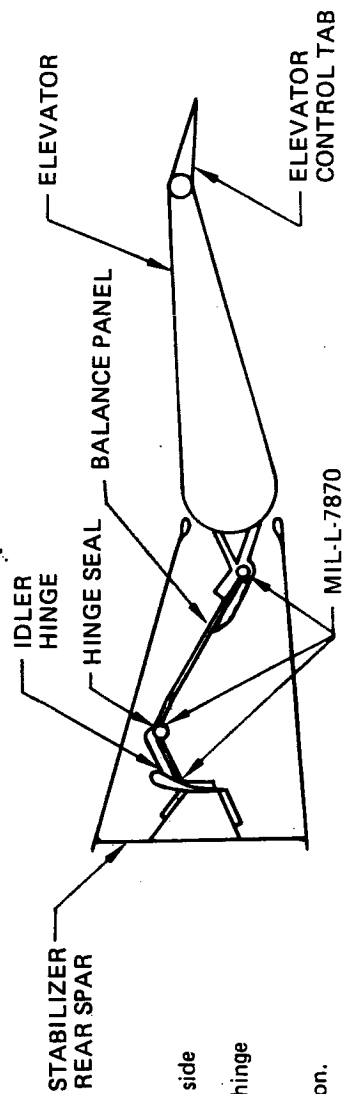
Elevator Lubrication
(Identical to Production Maintenance Document D6-8766)

Note: Remove access cover and bolts on lower side of balance panel for access to all hinges. Following lubrication, install bolts and hinge seal. Install access cover. Exercise control surface during lubrication.

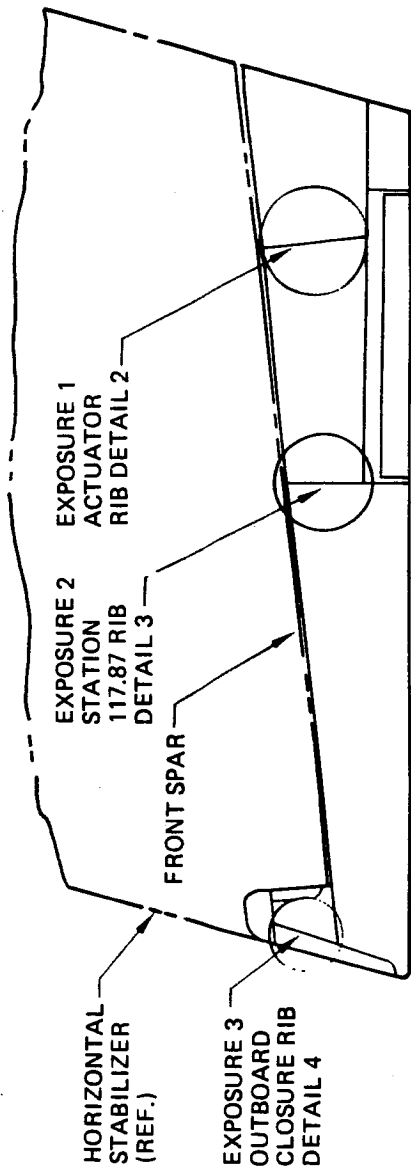
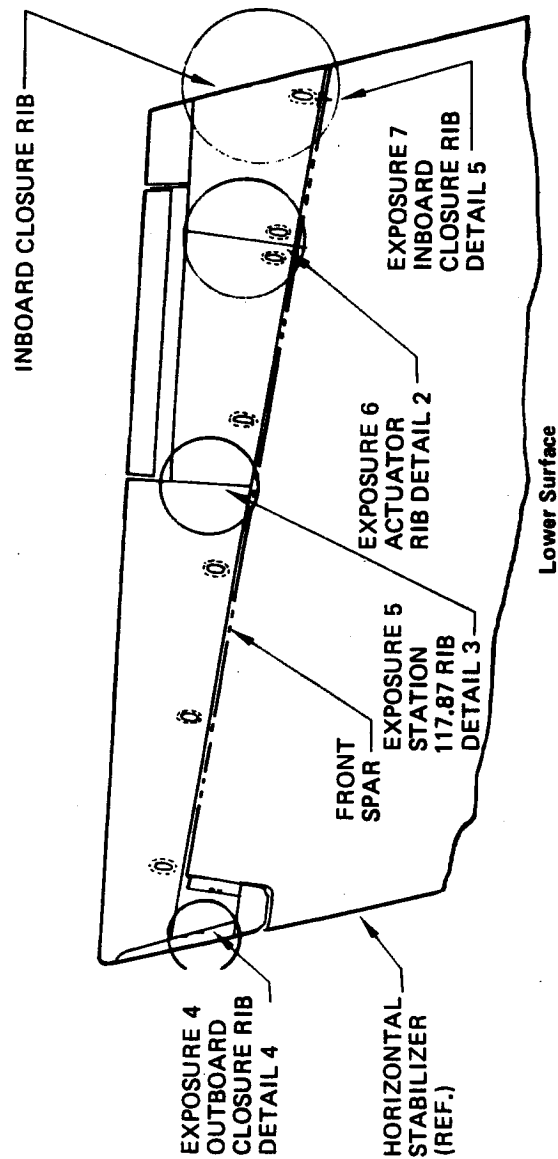
Detail 1. Graphite/Epoxy Elevator Exposure Positions (Left Hand Shown, Right Hand Similar)

Exposure number	Film			SFD* (in)	Generator settings	
	Number	ASTM class	Size (in)		kV	mAs
8	1 and 2	I	14 x 17	40	28-30	900

Upper Surface

Lower Surface

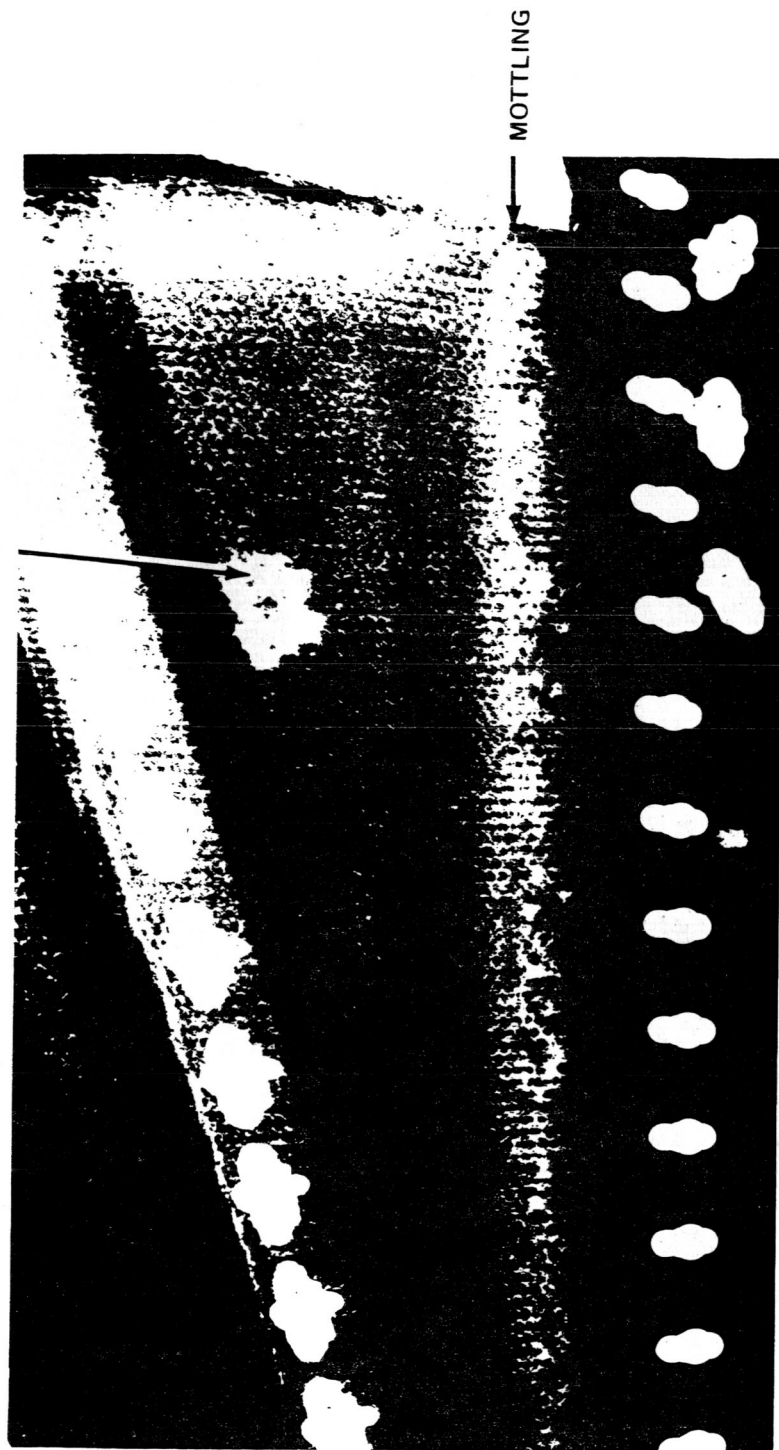
Figure 1. Moisture-Free Inboard Closure. Radiograph Taken per Detail 5

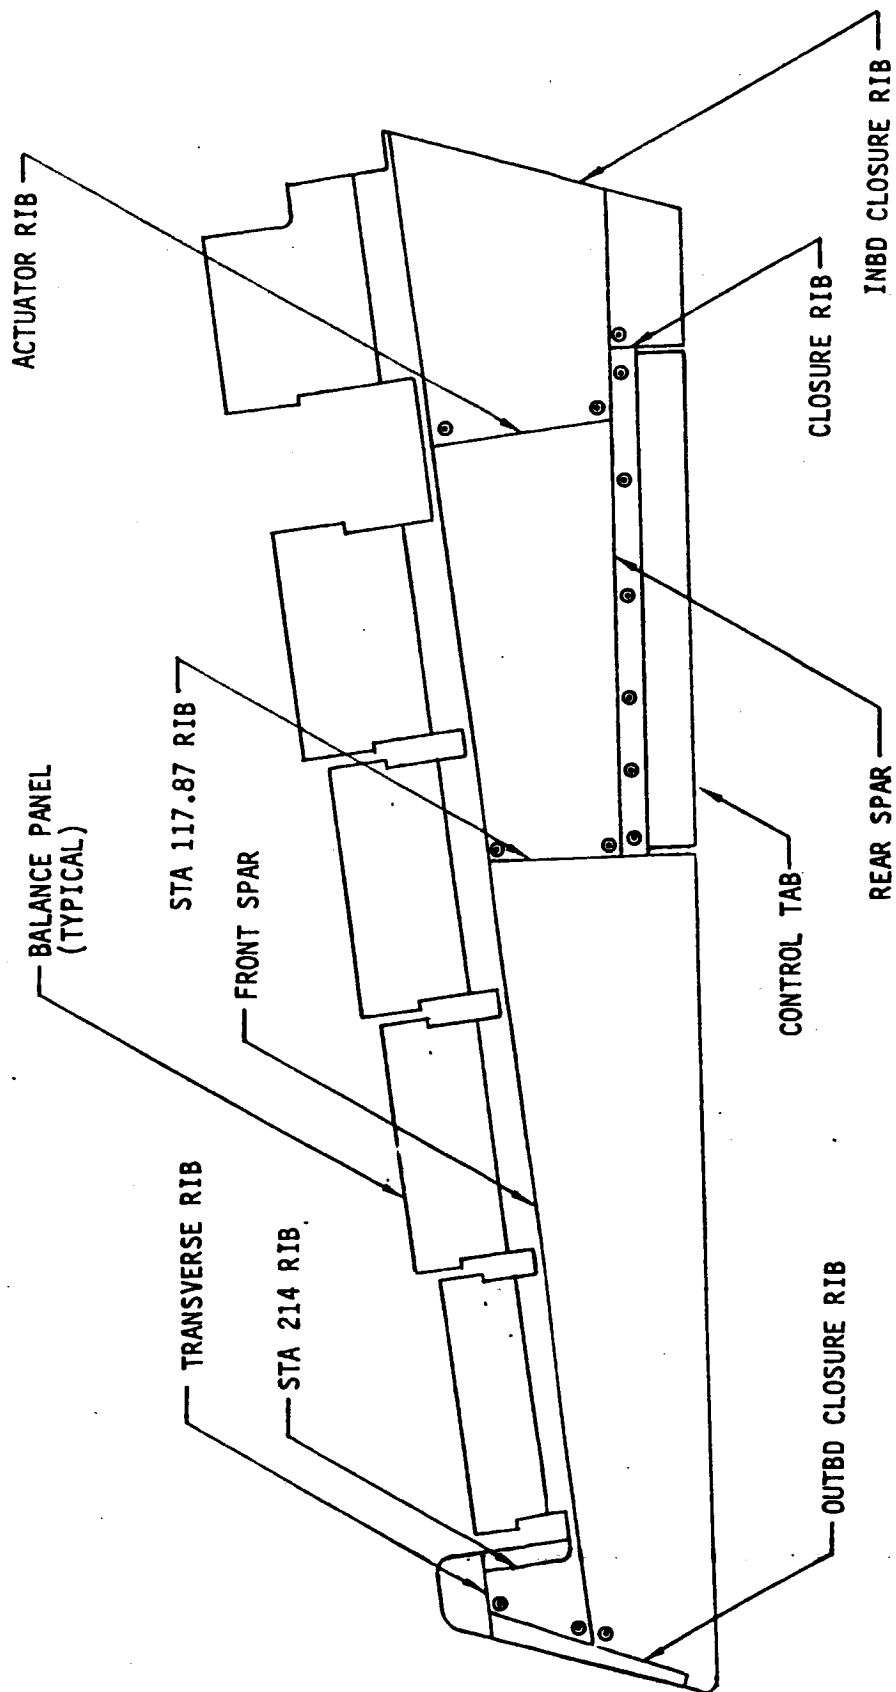
FIGURE 1.3 - DRAIN HOLE LOCATIONS IN THE 727 GRAPHITE/EPOXY ELEVATOR

- INDICATES A .375 INCH DIAMETER DRAIN HOLE LOCATION IN LOWER SURFACE

NOTE: Drain holes are .375 inch in diameter. Refer to Figure 1.3 for location.

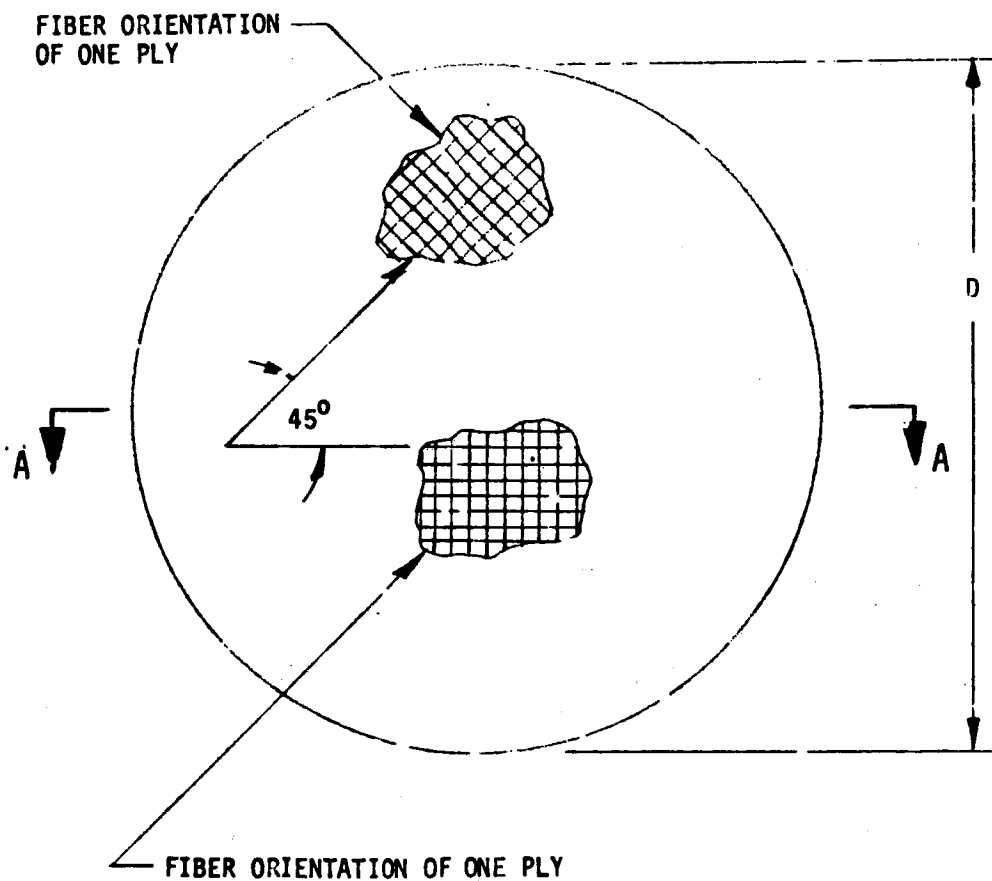
$$D = (\text{DIAMETER OF REPAIR CUTOUT PLUS 2.00 INCH}) \pm .05 \text{ INCH}$$

FIGURE 2.2 - PRECURED PATCH

Precured patches shall be fabricated using two plies of epoxy resin impregnated woven fabric per BMS 8-212 (plus one ply of Style 120 preimpregnated fiberglass per BMS 8-139 if any portion of the patch will be within four inches of the aluminum lightning strip.) In between the plies of graphite/epoxy fabric place one layer of BMS 8-245 Grade 08 adhesive film. See Figure 2.2 for configuration of precured patches. Vacuum bag the layup and autoclave cure per Figure 2.3.

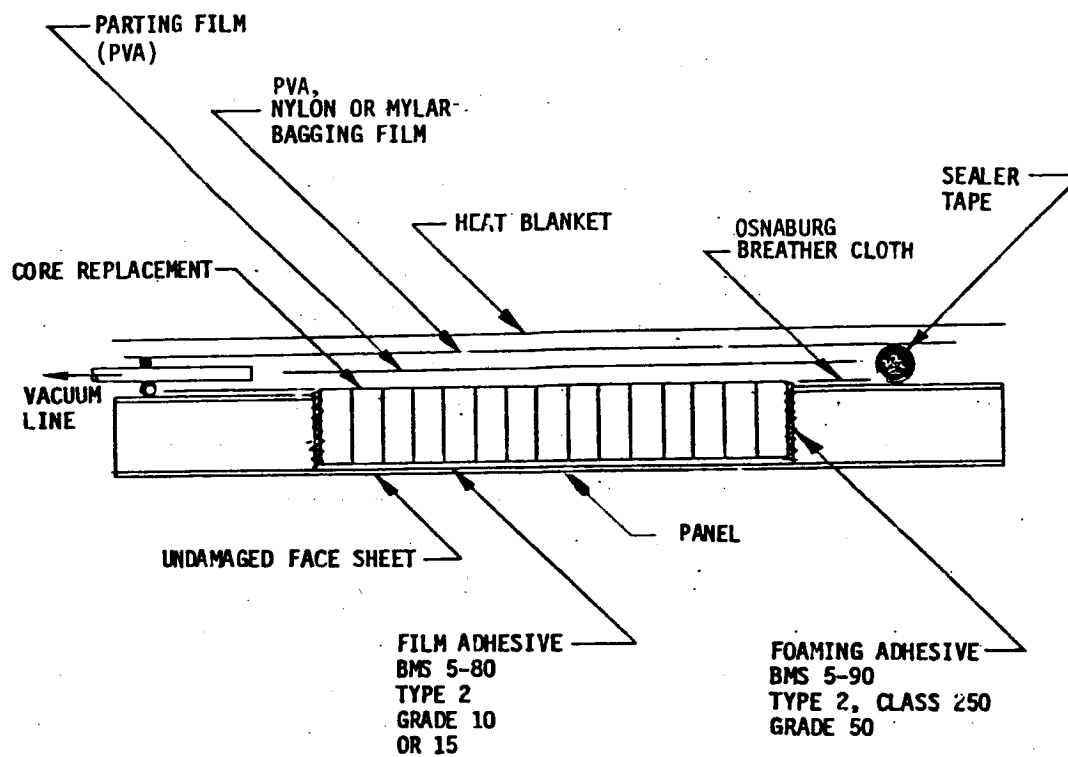
FIGURE 2.4 - LAY-UP ASSEMBLY FOR CORE REPLACEMENT

- (6) Clean out the repair area with oil free air. Wipe the surfaces with a clean cloth moistened with methyl ethyl ketone.
- (7) Apply one layer BMS 5-80, Type 2, Grade 10 or 15 as shown in Figure 2.4.

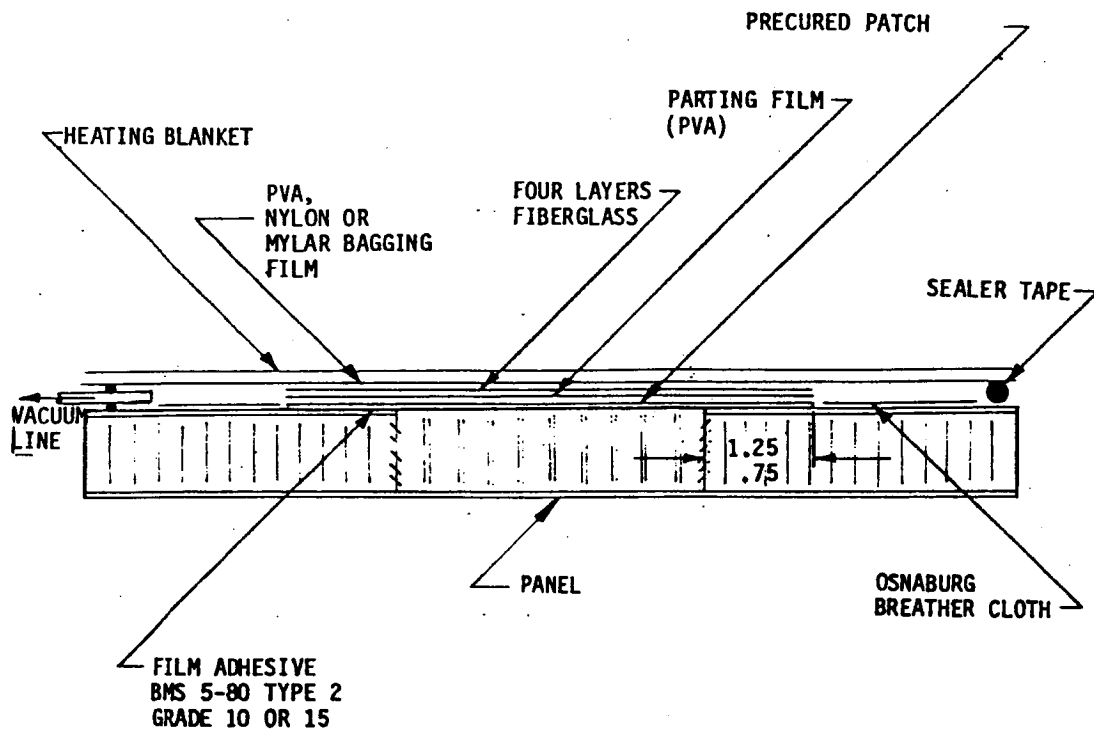
FIGURE 2.5 - LAY-UP ASSEMBLY FOR REPAIRING A FACE SHEET
USING A PRECURED GRAPHITE/EPOXY PATCH

- (18) Sand core flush with surface of panel. Caution: Avoid abrasion of the adjacent skin plies.
- (19) Cut precured patch and BMS 5-80, Type 2, Grade 10 or 15 to shape and size to give overlap dimension shown in Figure 2.5.

- (20) Apply one layer BMS 5-80, Type 2, Grade 10 or 15 as shown in Figure 2.5.
- (21) Remove peel ply from bonding surface of precured patch and locate the precured patch over repair area (Figure 2.5).

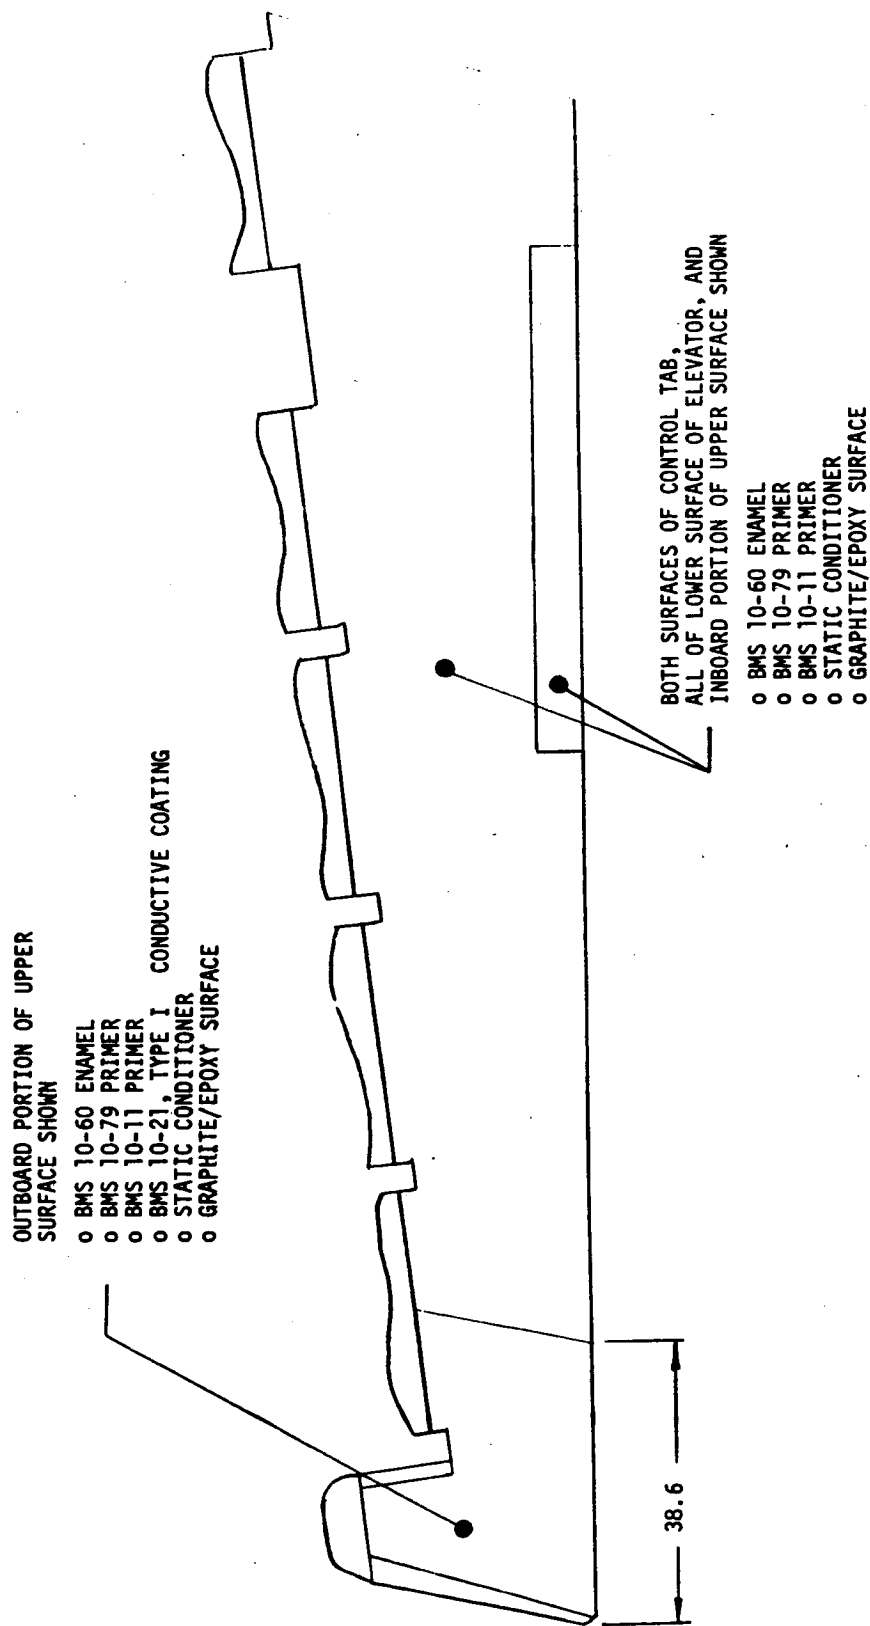
FIGURE 3.1 - FINISHES USED ON GRAPHITE/EPOXY ELEVATOR SURFACES

The graphite/epoxy components of the 727 elevator are protected by the finishes shown in Figure 3.1. Prepaint cleaning, pretreatment and painting of graphite/epoxy elevator components shall be accomplished in accordance with the sections of the "727 Maintenance Manual" listed in Figure 3.2 except no chemical paint strippers may be used to remove paint and the elevator or control tab must be rebalanced after painting in accordance with Section 4 herein.

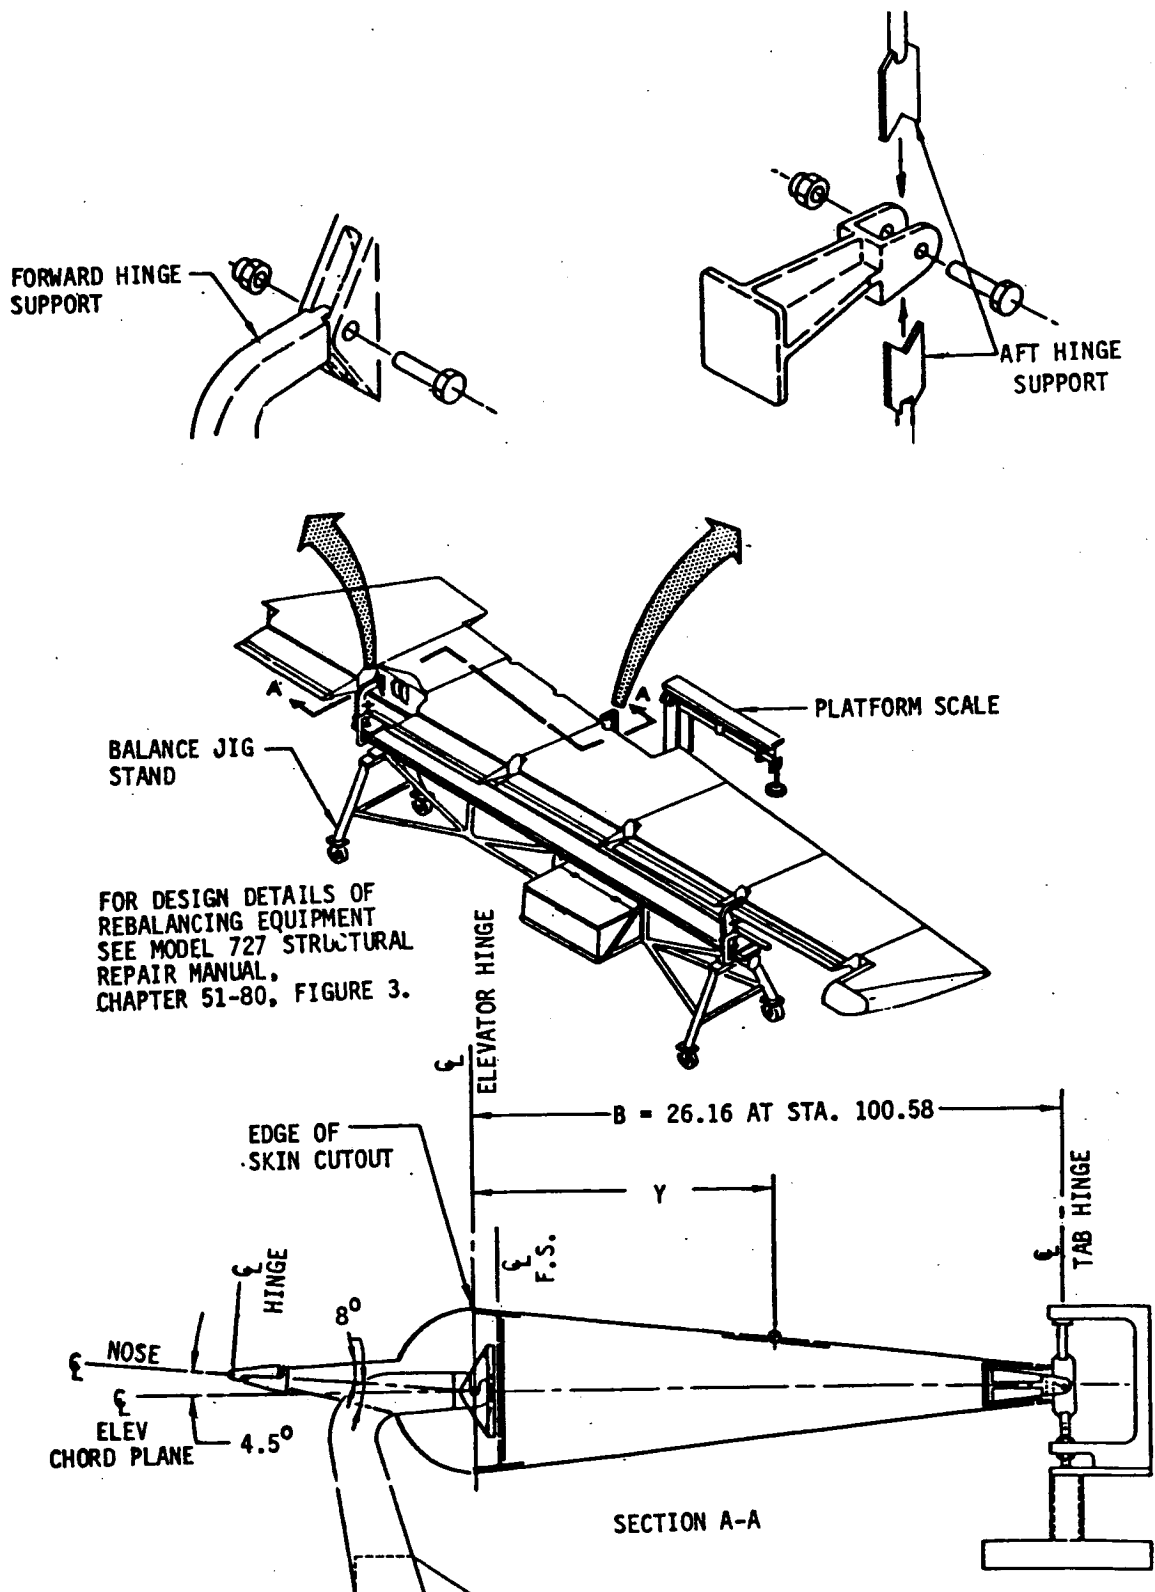
FIGURE 4.1 - ELEVATOR SURFACE REBALANCING

- (3) Mount the elevator (top surface up) on a balance jig stand as illustrated in Figure 4.1. See Figure 4.5 for mounting locations. When mounted as shown in Figure 4.2 the surface must be free to rotate a few degrees about the balance fitting without binding.
- (4) With the chord plane horizontal, obtain the weight reaction (W_R) at dimension (B) taken at the centerline of one of the tab hinges as shown in Figure 4.5. Use rear mounting point at either elevator station 100.58 or 118.59.

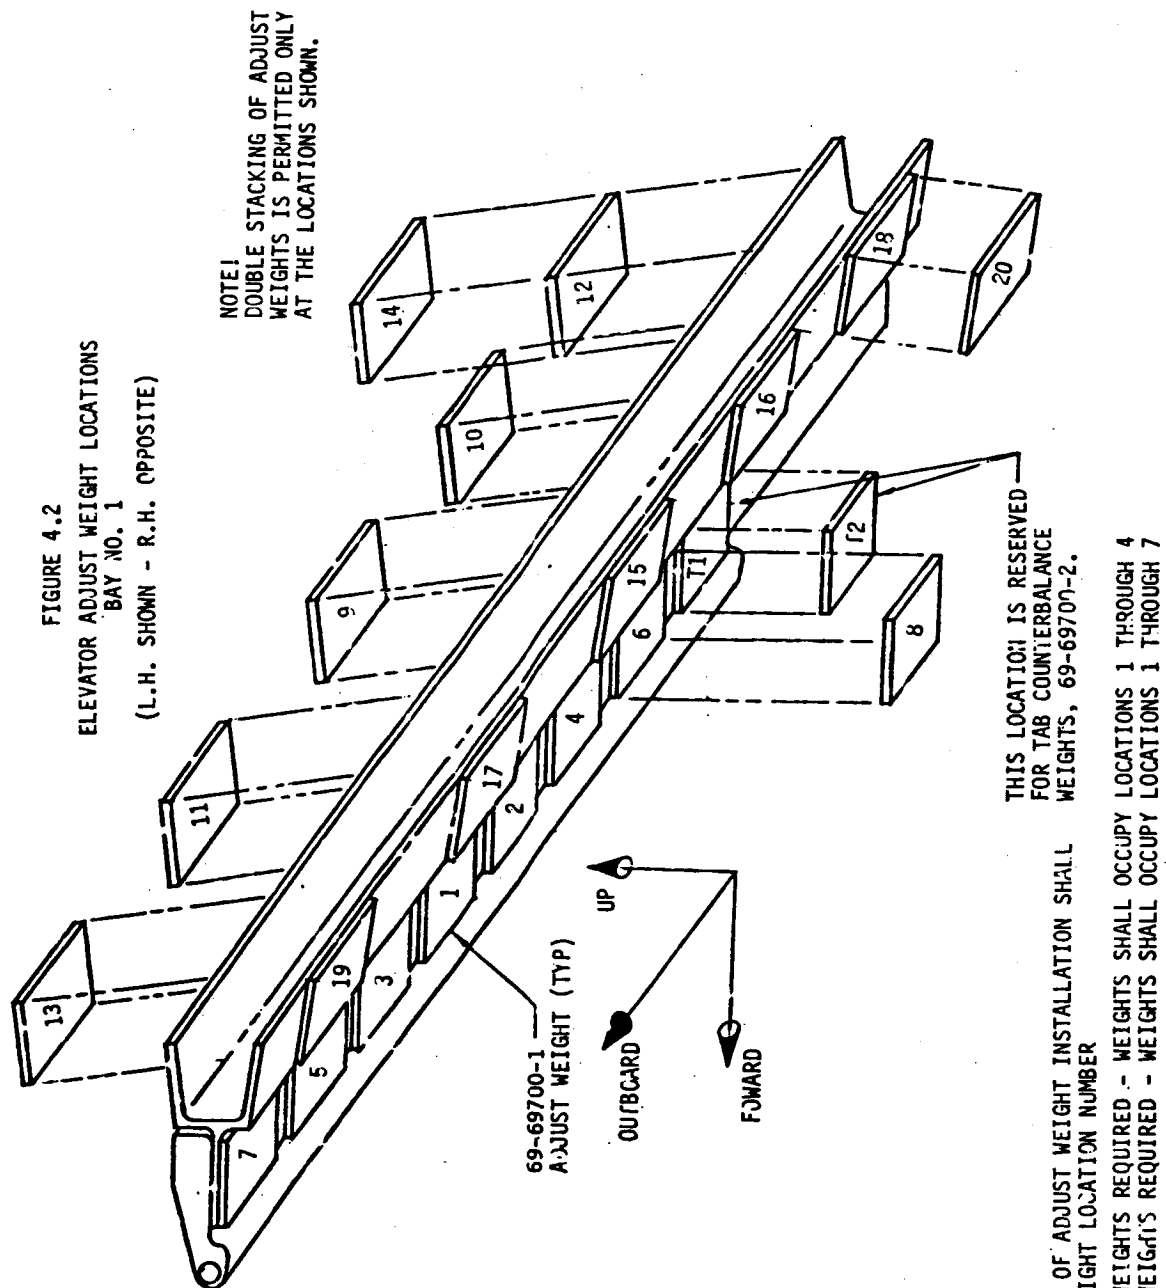
FIGURE 4.3
ELEVATOR ADJUST WEIGHT LOCATIONS
BAY NO. 2
(L.H. SHOWN - R.H. OPPOSITE)

- (8) When installing or removing balance adjust weights, strict adherence shall be observed to the location number system illustrated in Figures 4.2 and 4.3. Balance adjust weights are not to be installed in the space reserved in Bay No. 1 for tab counterbalance weights (69-69700-2), locations T_1 and T_2 . Balance adjust weights to be installed per Figure 4.4b.

- (6) Having determined the trial moment, refer to elevator balance table, Table 4.2, and read off the number of weights required.
- (7) If additional balance adjust weights are required they should be installed in the next highest location numbers unoccupied. See Figure 4.2 for Bay No. 1 and Figure 4.3 for Bay No. 2.

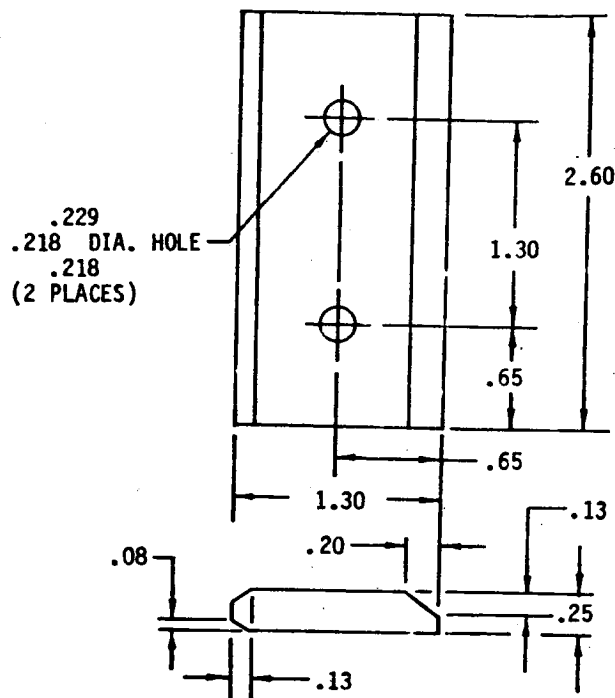
FIGURE 4.4a - ELEVATOR BALANCE ADJUST WEIGHT 69-69700-1
AND TAB COUNTERBALANCE WEIGHT 69-69700-2
NOMINAL WEIGHT 0.5 POUND

MATERIAL
TUNGSTEN POWDER COMPACT BAR
PER MIL-T-21014 TYPE II CLASS I
(DENSITY: 16.85 - 17.25 GRMS/CU.CM.)

NOTE! -2 IDENTICAL TO -1 EXCEPT
FOR FINISH.

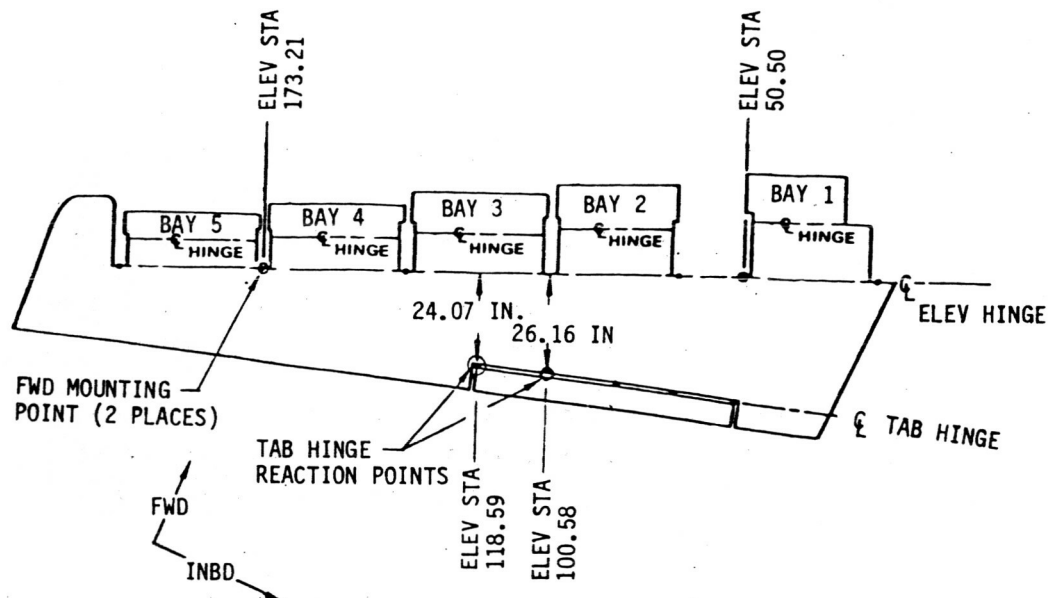
FIGURE 4.5 - ELEVATOR MOUNTING AND REACTION POINTS

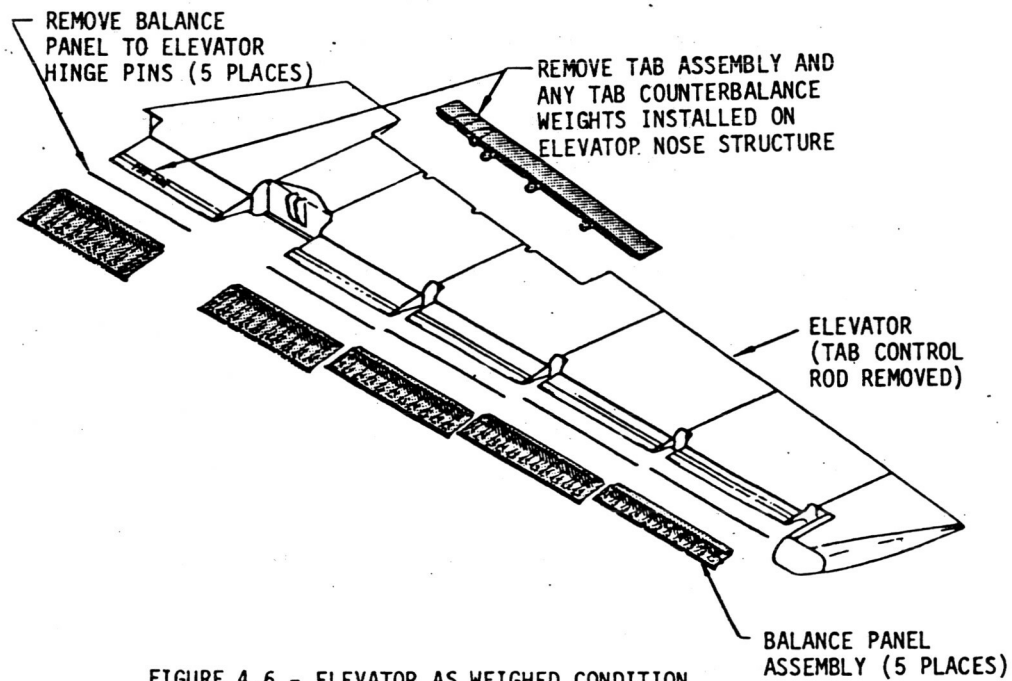
FIGURE 4.6 - ELEVATOR AS WEIGHED CONDITION

(2) The condition of the elevator surface for weighing and balancing is as follows: (See Figure 4.6).

- (a) Items that must be installed in their correct locations to ensure proper balancing:
 - o Tab hinge bolts, nuts and washers.
 - o Aft portions of the five (5) aluminum bronze elevator surface/balance panel hinges.
 - o All protective and decorative finish.
 - o All balance adjust weights installed on the nose structure at the time of elevator removal.
 - o All elevator surface nose seals.

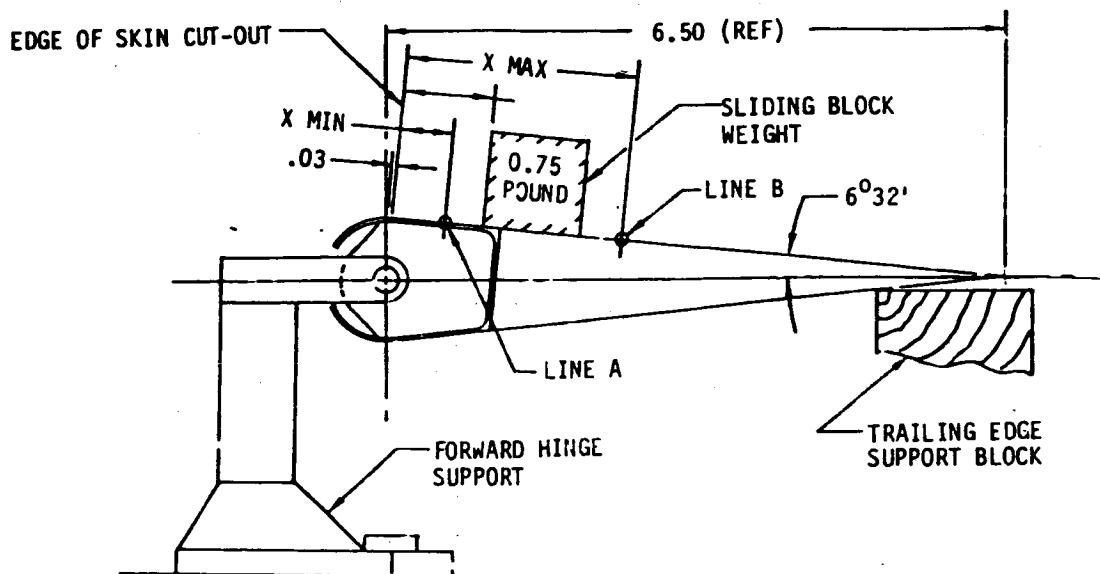
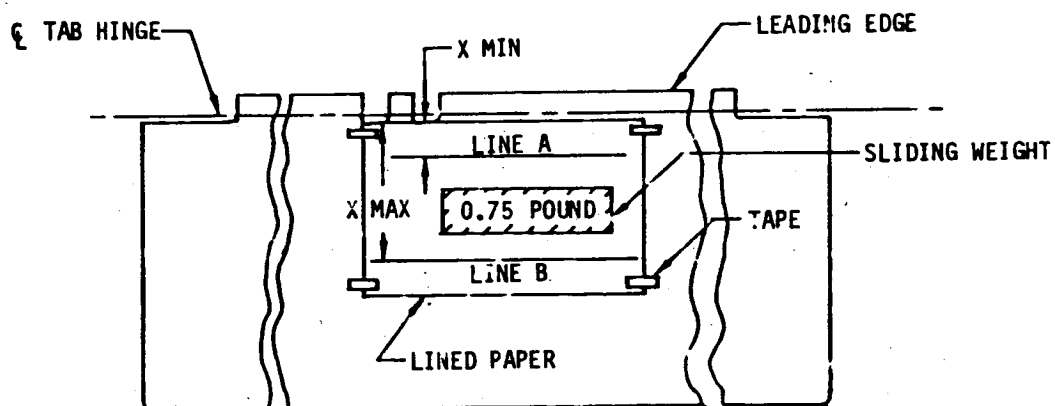
ATTACHMENT OF LINED PAPER TO UPPER CONTROL TAB SURFACE
 X MIN = 0.50 INCHES X MAX = 2.07 INCHES
 NOTE: X DIMENSIONS MEASURED AFT FROM CUT-OUT
 IN CONTROL TAB LEADING EDGE

FIGURE 4.8 - CONTROL TAB SET-UP FOR BALANCE CHECK

- (4) Complete all repairs, rework or repainting as required.
- (5) Weigh the tab. See Figure 4.7b for the as weighed configuration. All installation bolts, nuts and washers are to be removed.
- (6) Attach ruled paper on the control tab surface with the ruled lines parallel to the control tab hinge line as shown in Figure 4.8.

- (7) Refer to Figure 4.8 and using X minimum and X maximum dimensions draw pencil lines A and B parallel to the control tab hinge centerline as shown in Figure 4.8.

- (8) Mount the control tab on the rebalance fixture as shown in Figure 4.8 (see Model 727 Structure Repair Manual, Chapter 51-80 Figure 4.3 for a tabulated listing of rebalance equipment).

- (10) Place the sliding block weight (detailed in Figure 4.7a) on the ruled paper aft of line A as shown in Figure 4.8. Remove protractor level from the surface. Slowly move the block forward towards the control tab leading edge until the trailing edge just begins to rise away from the supporting blocks. Ensure that the sliding block weight is positioned parallel to the control tab hinge centerline. Use the parallel lines on the ruled paper attached to the tab skin for alignment.

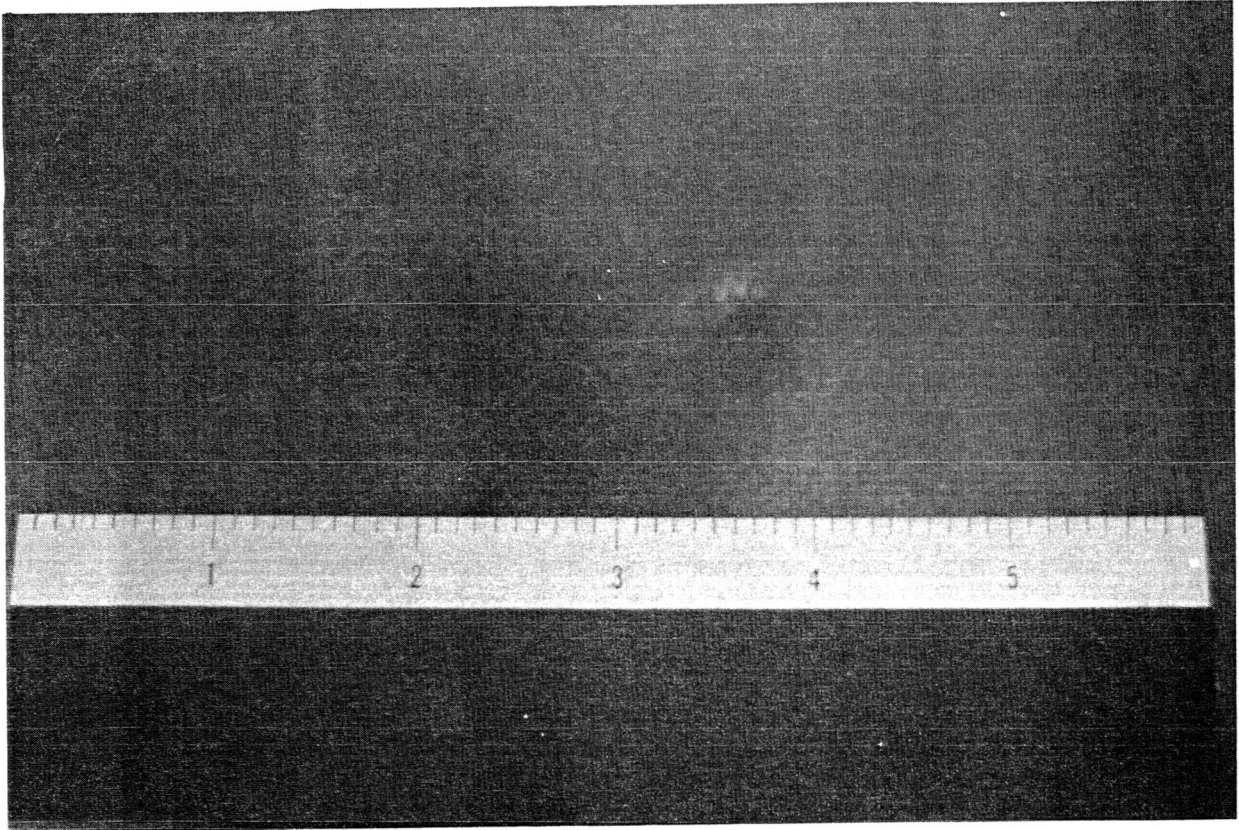
Figure A1.1. Damage to a Sandwich Panel Face Sheet

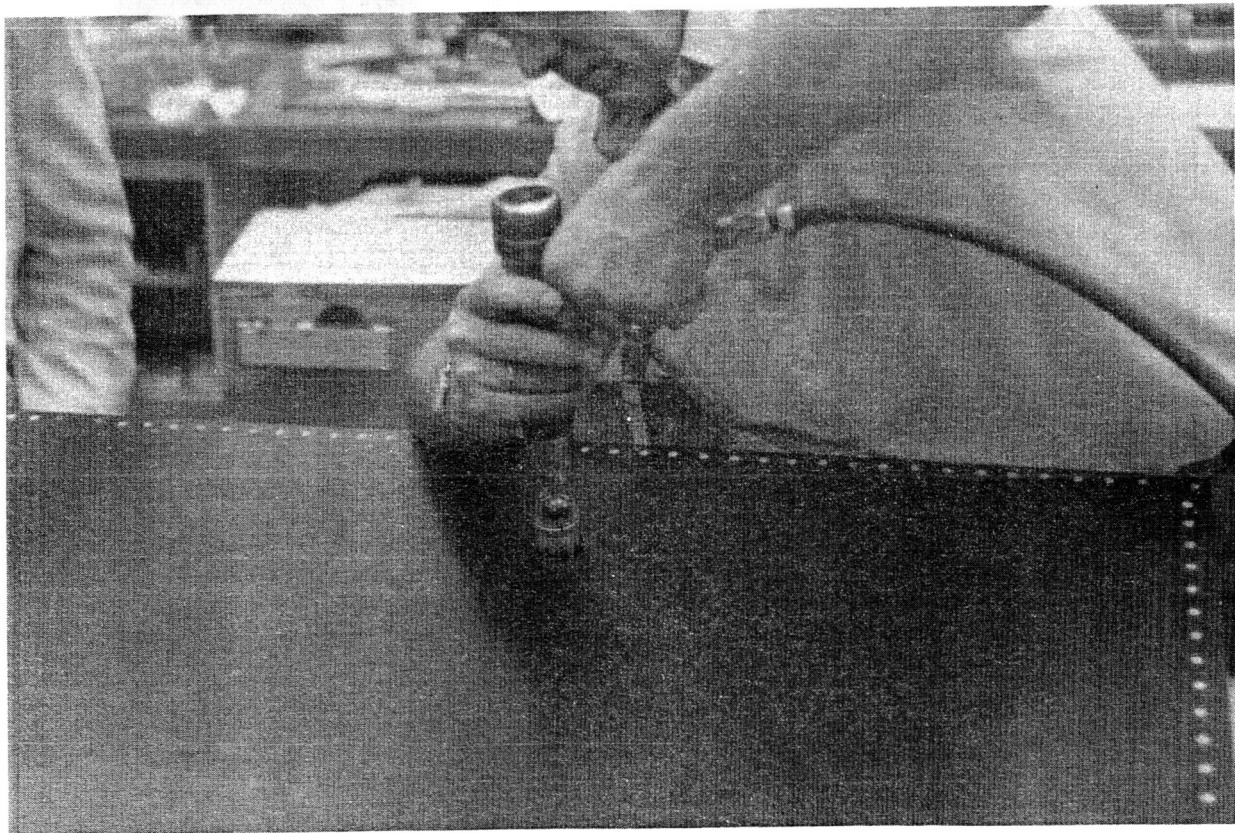
Figure A1.2. Removal of Damaged Face Sheet

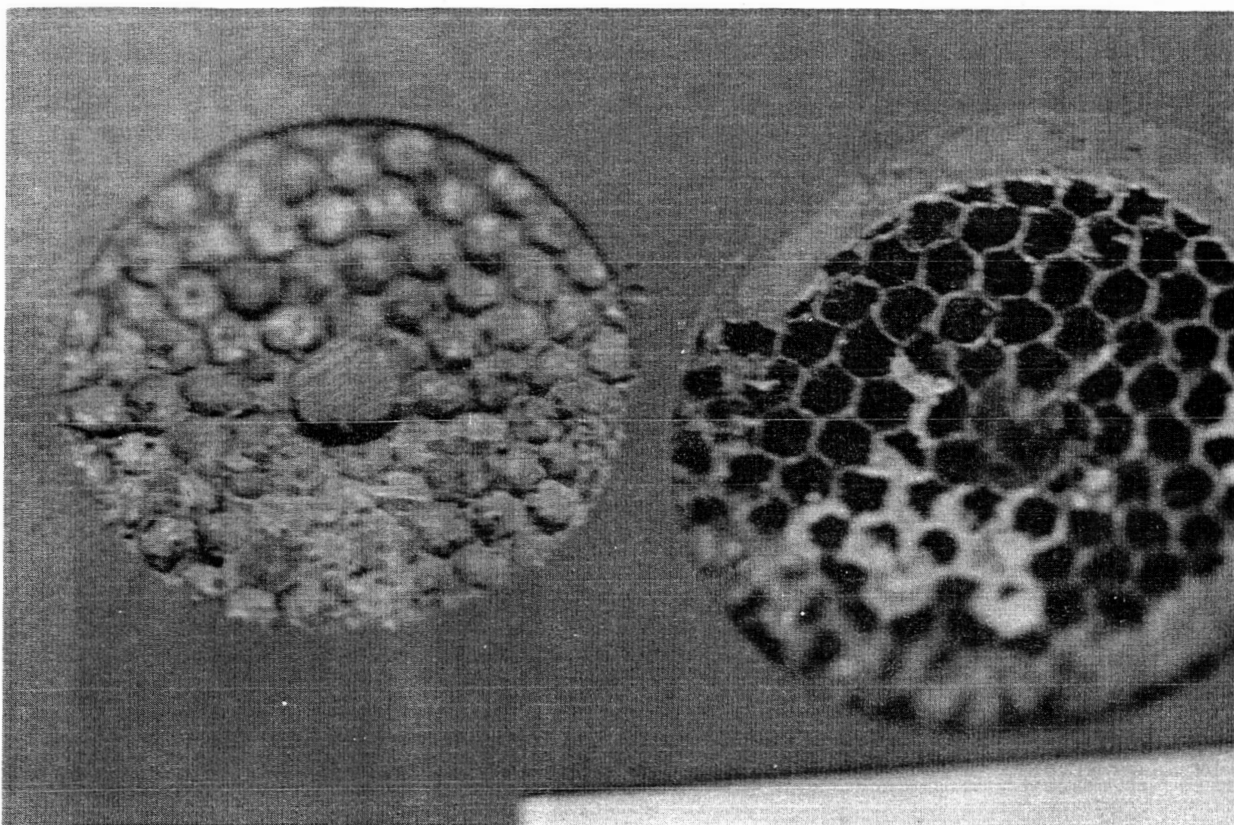
Figure A1.3. Damage Area in Skin Removed
